# FACILITY COMPLIANCE INSPECTION REPORT

## Division of Waste Management Solid Waste Section

**Date of Site Inspection:** 9 January 2012

Miller Farm LCID Landfill  
 Miller Farm Road  
 Morehead City, NC 28557

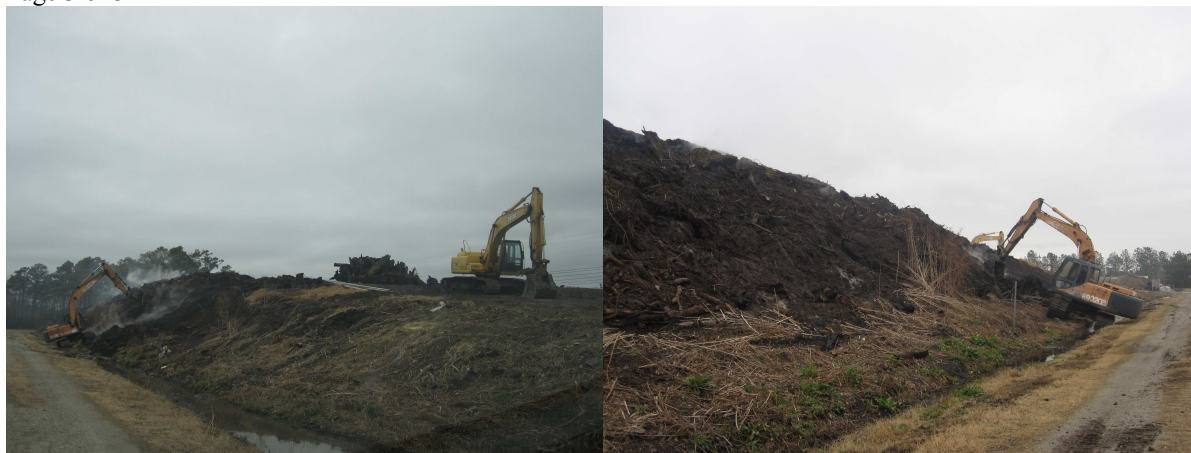
- 13) The facility operator is continuing excavating hot areas on top of the landfill to allow water to be sprayed down into the landfill and onto burning excavated materials. These operations will continue until the fire is determined to be out.

Excavators digging out burning material for wetting by sprayers

- 14) \*As is safely practicable, please continue excavating and pumping water onto the landfill until the fire is completely out.
- 15) The working face is compact and is being maintained within the marked two acre footprint. A buffer is being maintained between any newly received waste and the toe of the previously active landfill. All incoming waste is being manually placed and compacted at the working face with an excavator to keep traffic away from the burning areas of the landfill.

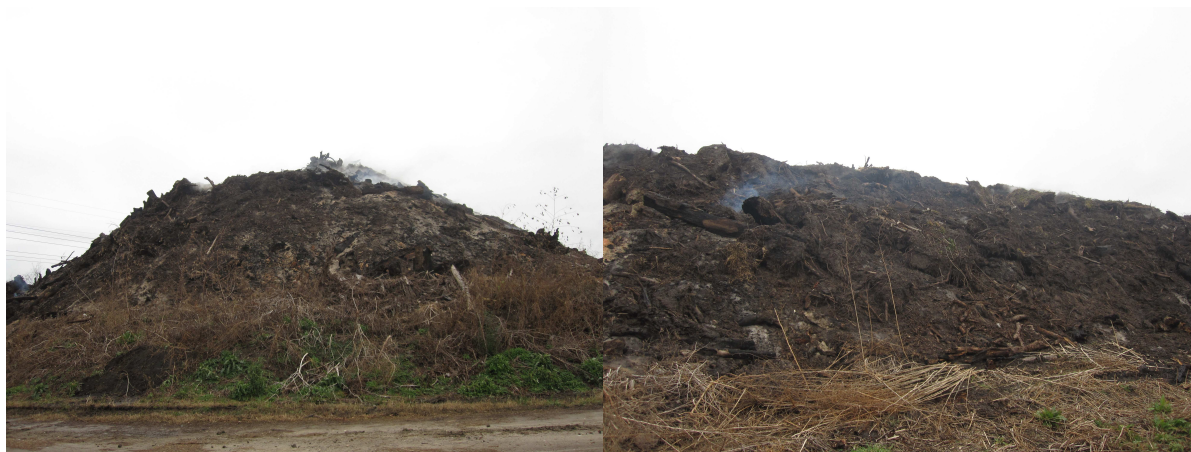
- 20) Overall, minimal smoke and no visible flames were noted during this site visit; however, as excavation and spraying are conducted, flames and smoke increase when burning materials are unearthed and exposed to the air. The flames and smoke subside as the materials are wet down and then smothered with soil.

Landfill cover crop and cap damage from fire and ongoing excavation-note minimal smoke

- 19) \*As soon as is safely practicable, please resume compacting and covering the landfill cap and sideslopes damaged during the fire incident. Once the repairs are completed, all sideslopes should be graded at a slope not greater than 3:1 and seeded and mulched to establish a groundcover suitable to prevent erosion.
